California Detection Systems, Inc.

March 14, 2014

Exide Technologies Leak Detection System Report

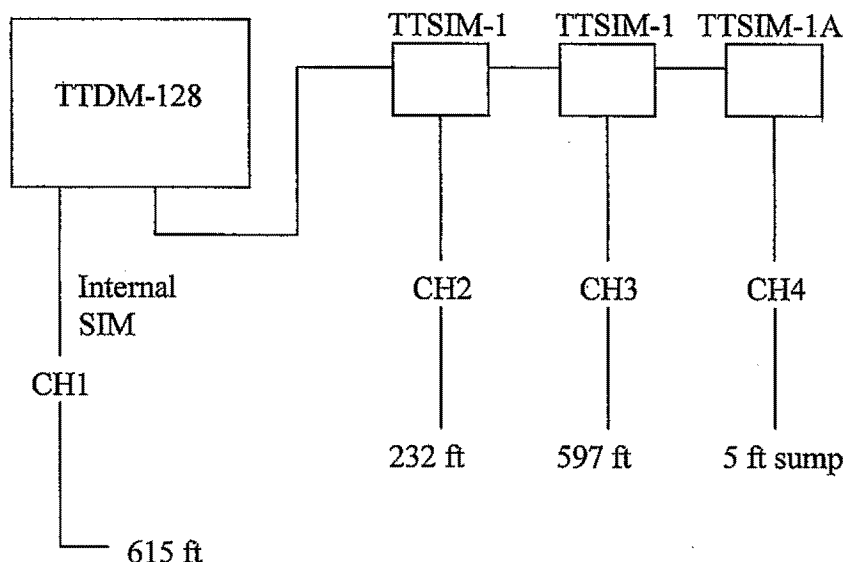
This system has taken considerable damage since its install approximately 5 years ago.

Channel 4, the sump monitor is the only channel that is still in operation and is indicating fluid at 2 feet along its length.

Channel 3 has an intact and continuous cable. It is detecting multiple incidents of fluid along its length. This is indicated by unstable measurements of resistance along the cable. The average location of the leaks is around 250ft to 270ft. The TTSIM-1 powering

Channel 3 is inoperable and needs to be replaced. Its circuit board is completely corroded. It is receiving power but not capable of alerting the TTDM-128 of its presence.

Channel 2 has a properly functioning SIM however the cable is destroyed. From readings in the control panel history this cable has been undergoing severe corrosive attacks for a long time. The effects of the corrosion were slowly building resistance in the cable until current could no longer complete the circuit and all instrumentation reads "Cable Break". When the cable was still continuous leading up to two weeks ago, the added resistance from the corrosion was so bad that it was comparable to if the cable was 14,000 ft long. This cable will need to be replaced.

Channel 1 is the internal SIM directly from the TTDM-128. This SIM, an integral part of the TTDM-128, is functioning properly. The cable on this channel is the same situation as that of Channel 2, it is destroyed and will need replacement.

- 1) 1 TTSIM-1 destroyed
- 2) 615 feet of TT3000 cable on CH 1
- 3) 232 feet of TT3000 cable on CH 2

An estimated budget for the replacement of nonfunctioning monitoring equipment and sensor cable is \$9,700.00
